DEVILS DISHFULL POND DAM
MA-01138

NATIONAL DAM INSPECTION PROGRAM
CORPS OF ENGINEERS

Identification No.: MA 01138
Stream: North Brook
City: Peabody
County and State: Essex County, Massachusetts

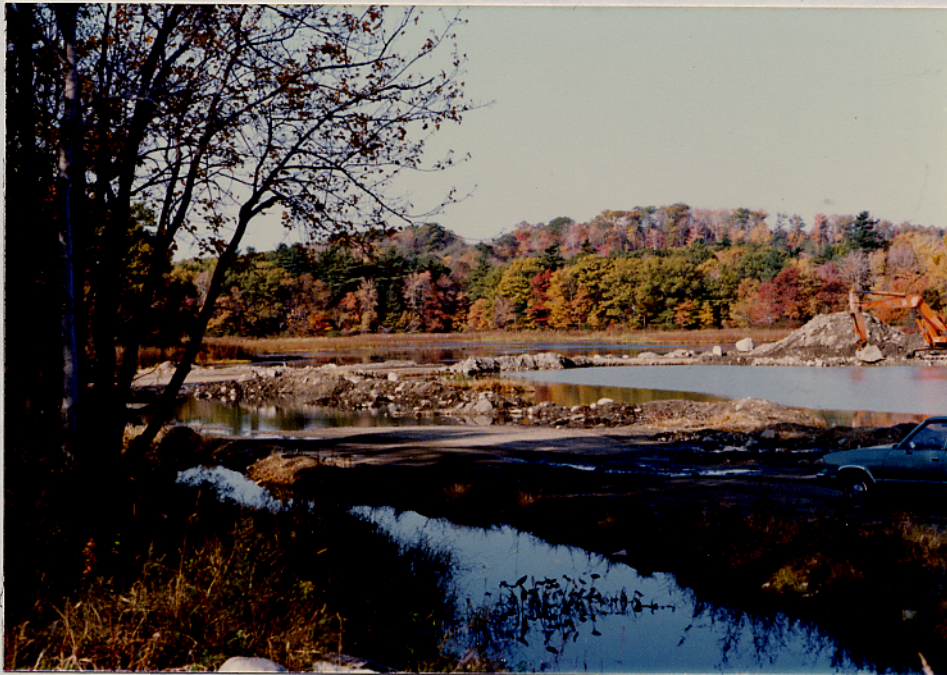
PHOTO NO. 1 - This view shows the pond area. Note the filled roadway and backhoe used for gravel excavation. The swamp/pond has a surface area of about 15 acres. The drainage area around the pond is 780± acres.

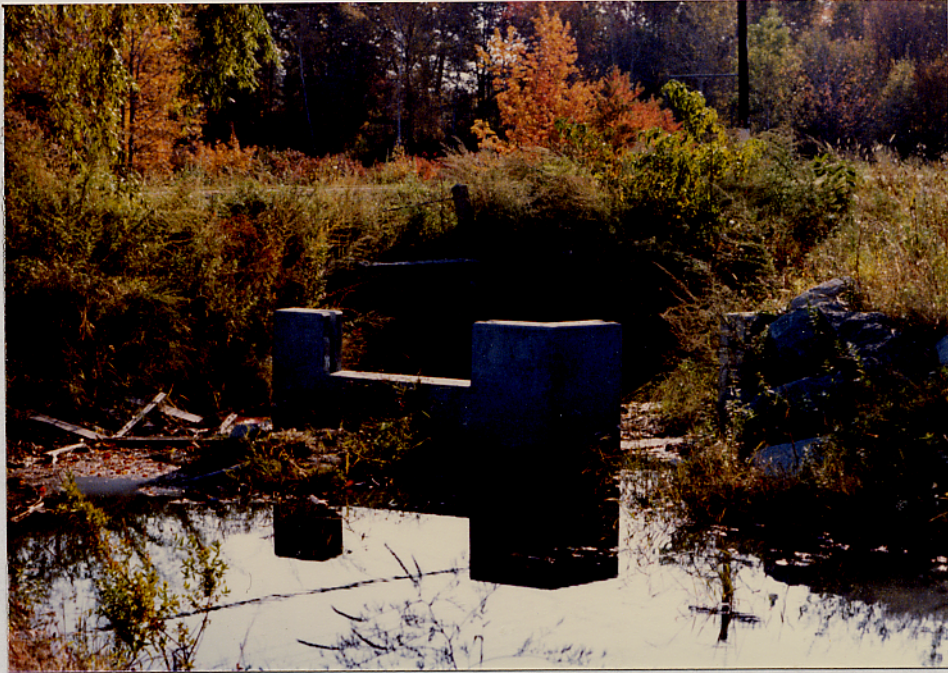
The pond is presently used as a gravel pit. A concrete outlet structure was constructed, which could raise the pond level, but it is not used. Discharge from the pond would be controlled by the 36 inch diameter metal culvert. The maximum culvert capacity could reach 50± cfs.

Should the 36 inch diameter metal culvert be blocked, water could rise and flow over the roadway. A "dam type" failure however is not likely to occur. Hazard potential is low.

PHOTO NO. 2 - The 36 inch outlet culvert and the concrete outlet structure are shown in this photograph. The left abutment at the outlet structure has been removed. The roadway embankment is about 5 feet high at this location.

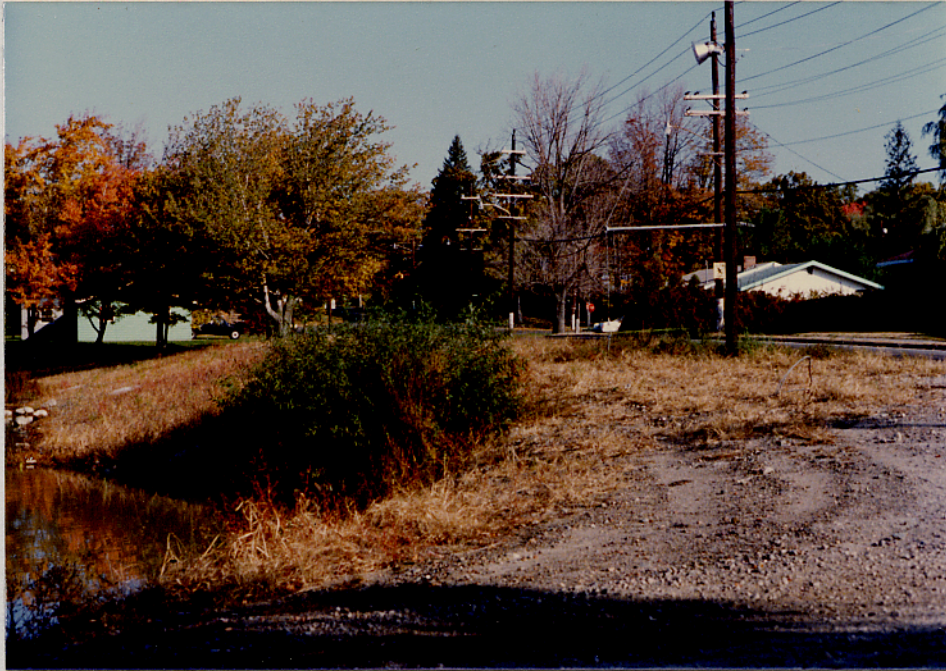
Devils Dishfull Pond Dam is located at Lake Street. It appears that a dam was never constructed at the pond outlet. Instead, a roadway embankment with drainage culvert was constructed. There were later modifications to increase the embankment and roadway size.

PHOTO NO. 3 - The roadway embankment which acts to impound North Brook, and form Devils Dishful Pond is shown in this photograph. The top of roadway is 50± feet wide. The embankment measures 100± feet in some locations.
